## Maryland Historical Trust State Historic Sites Inventory Form

1. Nam	e (indicate pr	eferred name)		
historic Sto	ne house			
and/or common				
2. Loca	ation			
Z. E001				<del></del>
street & number	north side of San	dy Hook Road, .06 m	ile west of Clark R	<u>oachot for publication</u>
city, town Sa	ndy Hook	vicinity of	congressional district	sixth
state Maryla	and,	county	Washington

Survey No.WA-III-098

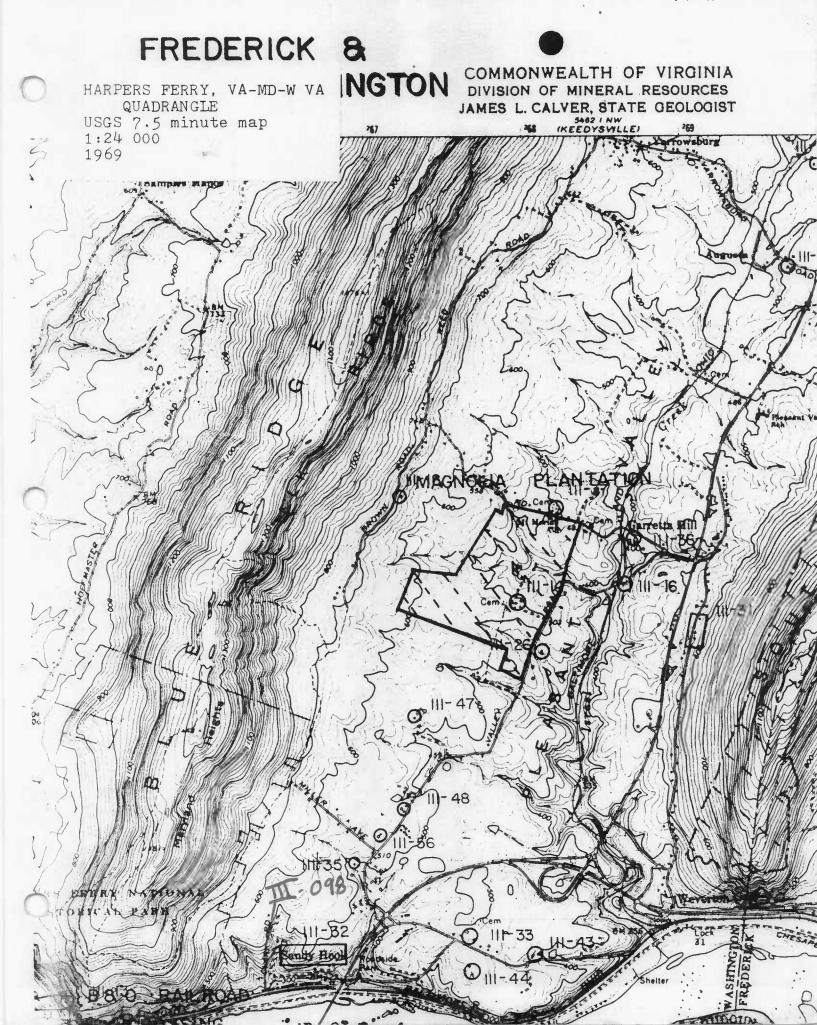
- 1. WA-III-098
- 2. Washington Co., Md.
- Joe Getty
   April 1983 7/82
- 5. Md. Hist. Trust, Annapolis, Md.
- 6. South elev. (camera facing north) 7. 1/1
